In-Situ Subsurface Coating of Corroded Steel Sheet Pile Structures

Final Report on Project F08-AR06

Final Report on Project F08-AR-06

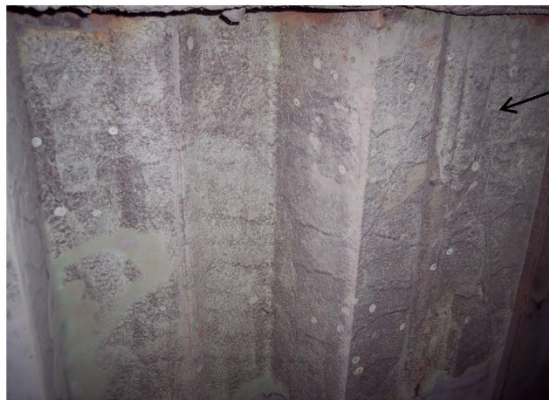
Corrosion is found only on some spots below the concrete coping beams, on the interlocks, on the spots with insufficient coating layer thickness and where mechanical damage occurred.

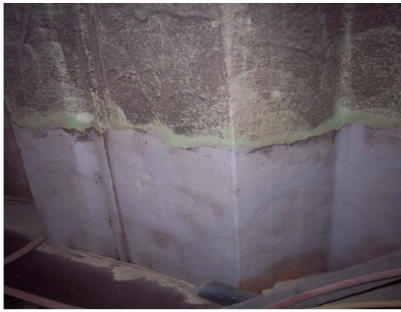
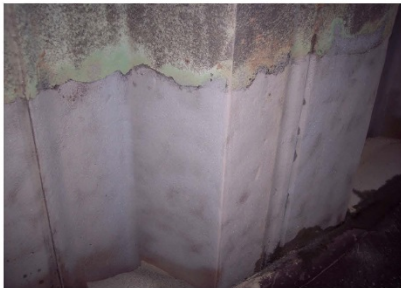
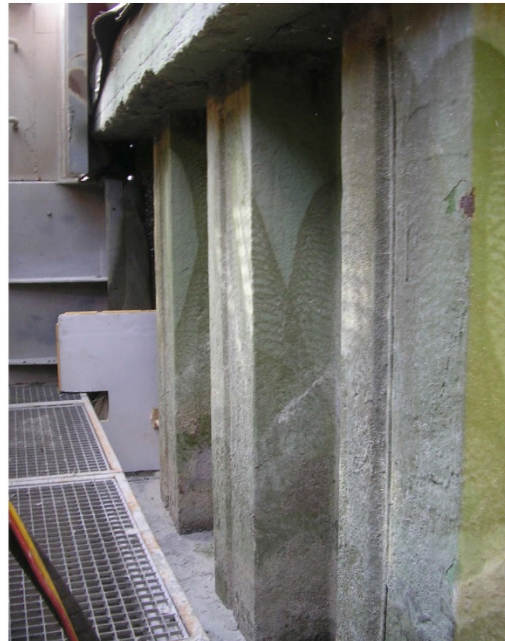
cleaned 24 year coating surface

At the bottom edge it is clear , that the Humidur ML that was applied in the past, has stopped corrosion. This picture demonstrates that corrosion continues deeper than the narrow band of 1 meter that was called to be typical for ALWC. Remark also the striations, some corrosion specialists call it : the "finger print" of MIC.

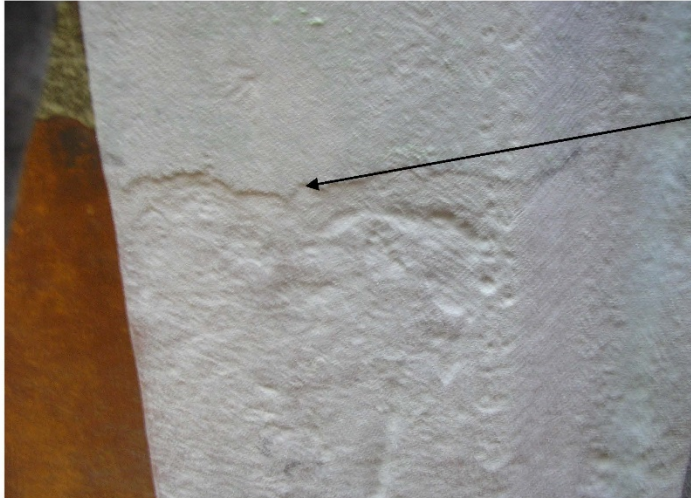
edge of the original 1985
Humidur - application
at -1,20m under water

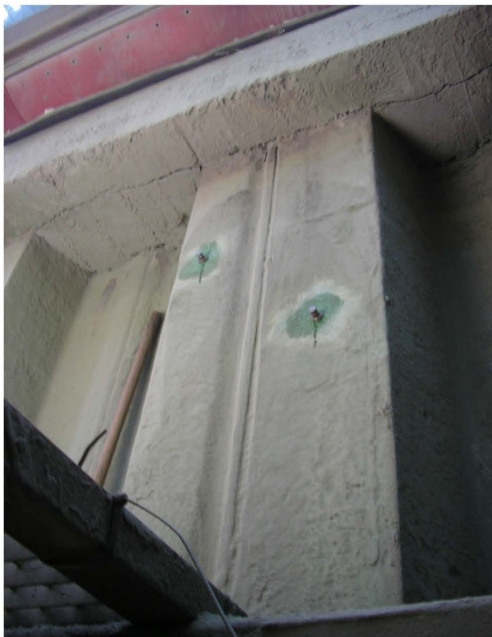
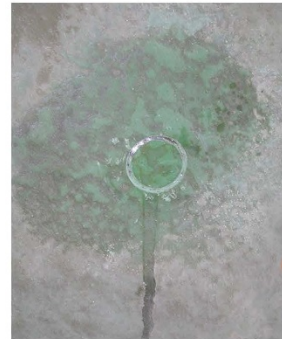
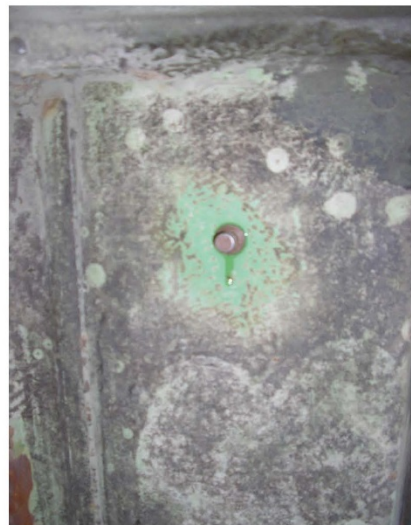
Humidur ML layer thickness : Phynix Pocket-Surfix

Average layer thickness : 829,5 μm
Maximum layer thickness : 1478 μm
minimum layer thickness : 294,0 μm

Inspection according to ASTM D 610-08

Evaluation Degree of Rust is present on surface

Rust grade:	10	less than 0,01%
General Rusting grade:	10-G	None
Spot Rusting grade:	10-S	less than 0,01%
Pinpoint Rusting grade:	10-P	None
